Introduction

This guide is designed to provide essential knowledge for optimizing the sealing process of Viva's injection-molded polypropylene tubes with in-mold label decoration. It also includes additional adjustment and troubleshooting techniques to help ensure the highest quality seals.

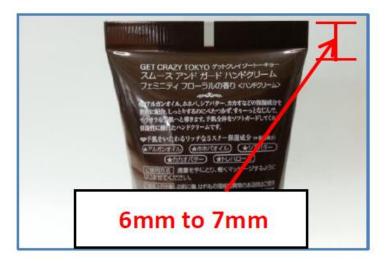
Crimp Height Considerations

The standard crimp height is approximately 6 to 7 mm.

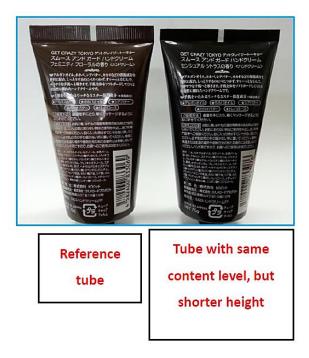
• To Shorten the Total Height While Maintaining Content Volume:

Lower the entire cutting unit. This adjustment allows the tube content volume to remain unchanged.

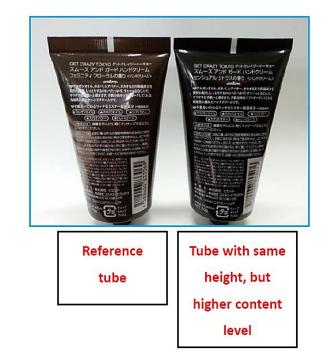
• To Maintain Total Height With Increased Content Volume:

Lower both the turntable and the cutting unit by a few millimeters. This modification will increase the tube's content capacity while keeping the overall height consistent.

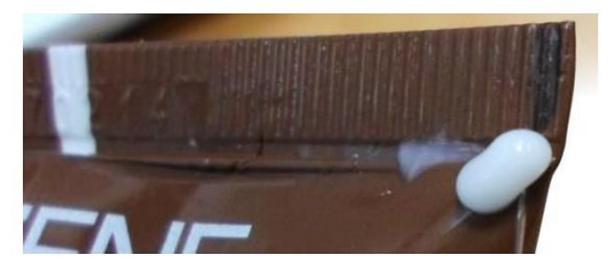
E. Leakage at Tube Seamline

Problem: Seamline bursts, causing product leakage

Cause	Recommendations	
Tube sealed with artwork seam too close to the edge	Ensure the label seamline is at least 5mm away from the tube edge to prevent folding.	
Folded edge compromises the strength of the seamline	Adjust the eyemark to the exact center of the back of the tube.

- Hot Jaws are not recommended for sealing polypropylene tubes.
- Do not fold the tube at the artwork seam.
 - The artwork seam is meant to be positioned approximately 5mm from the right-hand side when looking at the back panel.
